Manhole Inspection Summary

Manhole # S35AA_007MH

Insp Date: **11/13/07 10:52 AM**

Location Address: **hargrove alley**

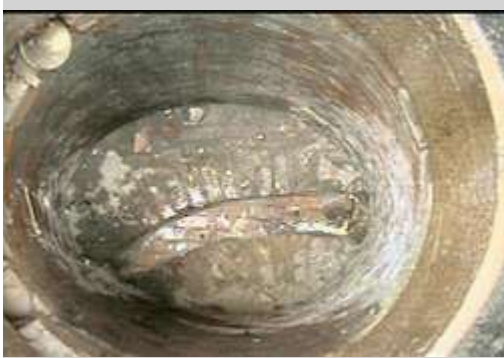
Defect 1

Condition: ☐ Sound ☐ Cracked ☐ Root Intrusion ☒ **Loose Brick** ☐ Deteriorated

Infiltration: ☐ None ☐ Joint ☐ Cracks ☒ **Mortar** ☐ Roots ☐ Wall

Steps Count: **0** Missing: **3** ☒ **Corroded**

corroded/missing steps, corbel loose bricks and infiltration through mortar

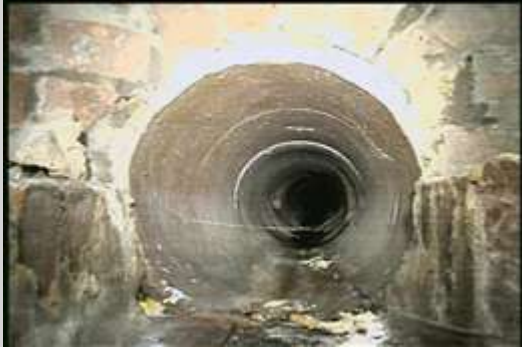
12 O'Clock Outflow

8 in. Circular Gravity Sewer
Pipe Out @ 12 O'Clock

Infiltration: **None**

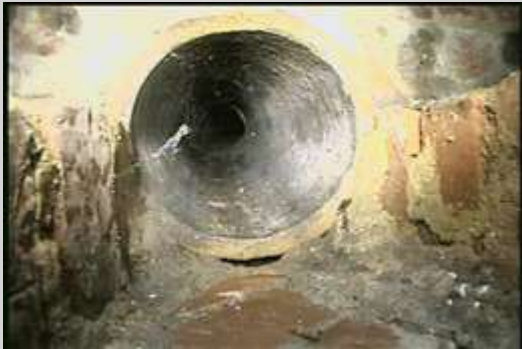
5 O'Clock Inflow

8 in. Circular Gravity Sewer
Pipe In @ 5 O'Clock

Infiltration: **None**
